# STRENGTHENING THE DAMAGED WOODEN COLUMNS AFTER INVESTIGATING OF SEVERAL INTERESTING APPROACHES FROM ABROAD

## ABSTRACT

The article describes an accident in colonnade of the 200 years old church, "Sv. Uspenie Bogorodichno" in Kyustendil. The article has investigated several interesting approaches to amplify damaged wooden columns in historical structures in China, Azarbaijan, Iran, Spain and USA. The decision was made to temporarily reinforce the whole structure of the church during its renovation and the method of strengthening the damaged wooden columns in the church was propose. The church was built in 1816, and is made of stone walls and a wooden roof structure. It is built according to the traditions of the Revival Age in Bulgaria and consists of walls with stone masonry, wooden floor constructions for emporium, wooden beams and columns. The outside walls are made of brick stone with a thickness of 60-70 cm. The building of the church is on one floor with height to the emporite-3.30m, height to the roof of the church with H-2.40m, with double sided roof, made with wooden constructions and roofing: boarding, waterproofing and tiles and three drum wooden dome. According to th

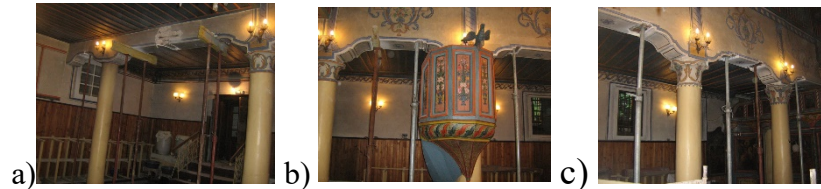
Fig. 1a, b, c. Replacing in certain places the longitudinal wooden beams located above the wooden columns with metal stands from the Hünebeck scaffolding on the A axis.

On the day of 16 June 2015, a partial temporary reinforcement of the church's support structure was carried out, covering certain areas under the longitudinal wooden beams above the wooden columns, with metal stands from the Hünebeck scaffold (Figs. 1a, b, c).

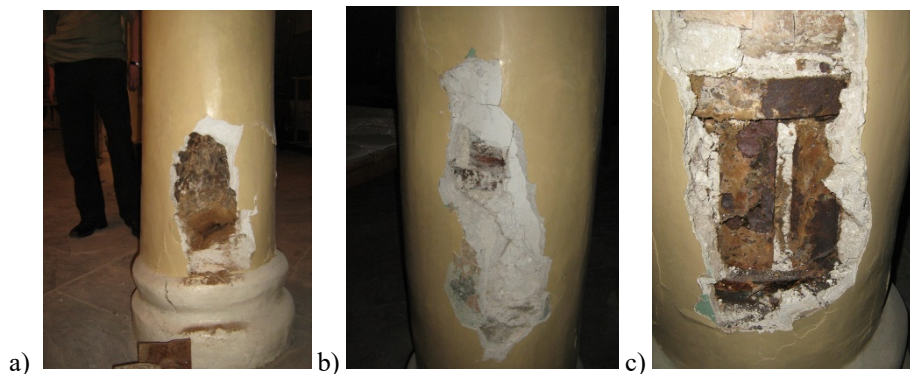
The observation carried out on the damaged and cracked cover on the columns and its detection in several places made it possible to describe the following facts. The wooden columns have a circular cross-section with a diameter of 46cm. Their support is done on stone base that protrude above the floor of marble slabs at a height of about 50cm. The revealed wooden columns show an interesting composite wooden-steel structure, made of timber, on which steel rings are attached (Fig.2a, b, c).

Fig. 2a, b, c. Cracked outer cover of the column in the church shot at 16.06.2015 at 18.30 hours. The ties are arranged side by side, on which about 40 cm are placed steel rings with a height of 40 mm and a thickness of 2.0 mm. The rings are attached to the wooden column with ordinary iron nails

The proposal for a design-construction solution for the rehabilitation of wooden columns in the naos of the church “Sv. Uspenie Bogorodicno”, taking into account the high pressures in them, the disturbance of the wood structure at the lower end and the unfavorable humidity and temperature conditions for many years of work will be done in several options according to the above mentioned examples. The ways are varied and they are coordinated with the competent authorities of the Institute of Cultural Monuments in Sofia. For our cases, however, the most commonly applied solutions are the dentures of columns with wooden dentures which reach 1-2 m height. However, before replacing the edges of columns with healthy wooden parts of the same type of wood, it is necessary to identify the causes of their rot. The explanation is that it is necessary to isolate these agents in the future leading to the decay of the wooden structure of the columns.

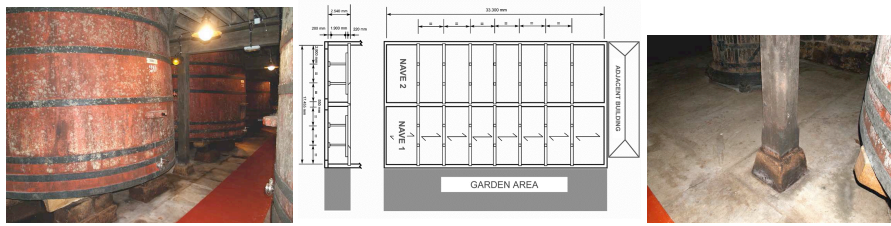
In 2011 the collapse of one of the timber pillars of the centuries-old warehouse of maceration that the firm "Bodegas Bilbaínas, S. A.", helds in the town of Haro (La Rioja), occurred[1]. Specifically, these primitives maceration and fermentation naves, which still keep the ancient wooden vats built in 1859 (Fig. 3, 4, 5 ).

Fig.3,4,5.Vats and Cellar floor timber structure and cross section respectively

The pillars, spaced at regular distances of 2.90 m from each other and the side walls, with approximate section 220x220 mm and height 1.90 m, lead from stone bases of 200 mm on edge. Moreover, as discussed above, to a height of only 1.90 m, sections close to the 220x220 mm, the associated mechanical slenderness round the value of  $\lambda = 32.90$ , so it can be said that the security against buckling, for all the timber pillars in the same condition, is fully guaranteed.

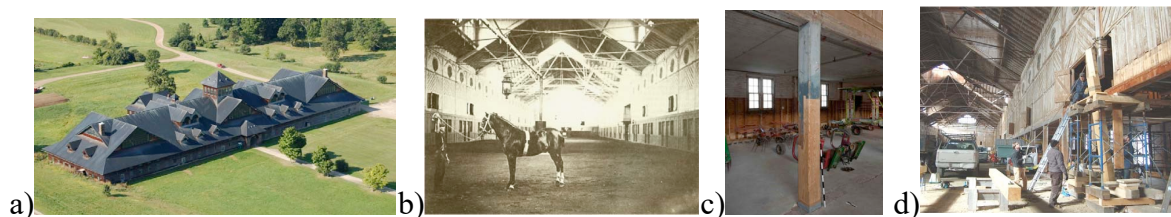
Fig.11a,b,c,d. The Breeding Barn at Shelburne Farms

Trusses are supported on timber columns around the perimeter of the riding ring and bear most of the roof weight (Fig.11b). Strengthening of the wooden columns was done by cutting of the decayed part and substitute by with new wooden part (Fig.11c,d). Columns were repaired by scarfing in new timber to replace decayed portions, using a nosed scarf form found elsewhere in the barn. New column bases were placed on limestone plinths and white oak shims, elevating them above a concrete floor installed in the mid-20th century. In four cases, column splices were made at the aisle level, requiring renewal of girt joinery and replacement of the girts on either side.
